Reflective Cracking Testing Notes

Date: February 16, 2015

Project: Reflective Cracking Indoor Phase IV

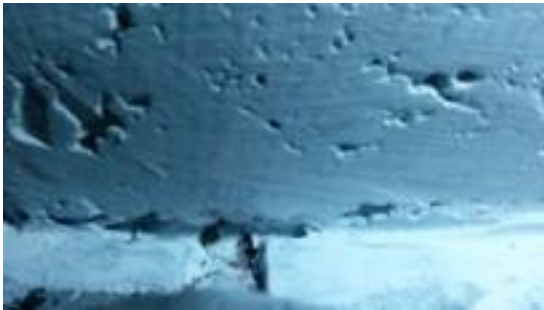
Figure 1. South Inner Vertical Edge.

The 12 mil formal test continued on the Phase 4 test item. On the South test section, the inner vertical edge remains unchanged from the pre-test condition. The outer vertical edge shows no cracks. As for the North test section, neither the inner nor the outer vertical edges show cracks at this time. The chiller remains inoperative due to a low flow fault. The ambient temperature is reading 27 °F. The temperature at the interface is reading 29.8 °F (T1-S) and 30 °F (T1-N). Figures 1 – 4 pertain to the current status of the reflective cracking test item.
